Seismic Evaluation Report For:

DAYS CREEK CHARTER SCHOOL - GYMNASIUM

Douglas County School District #15 Days Creek Charter School Seismic Evaluation November 2022 Project No: G-1540-22

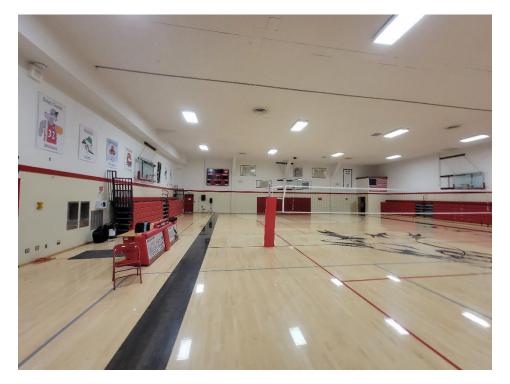
Figure 1: Gymnasium Interior

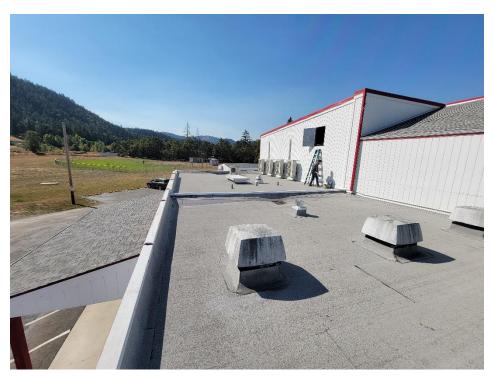
Figure 2: Roof Above Entrance Showing Roof Steps

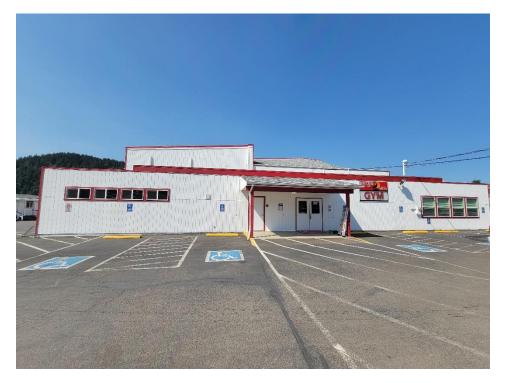
Figure 3: Gymnasium Entrance

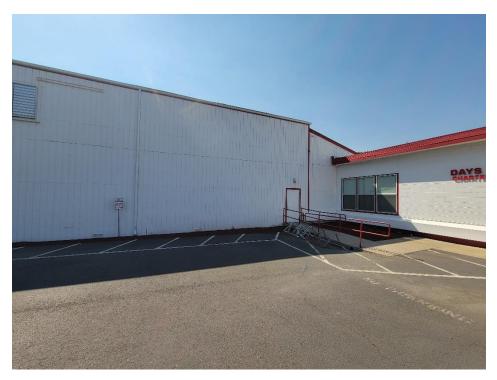
Figure 4: Gymnasium Wall with Connection to Classroom Building

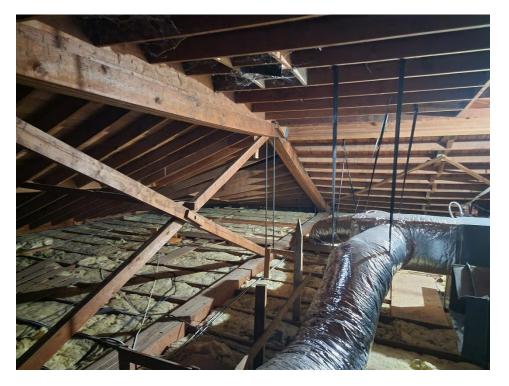
Figure 5: Attic Space

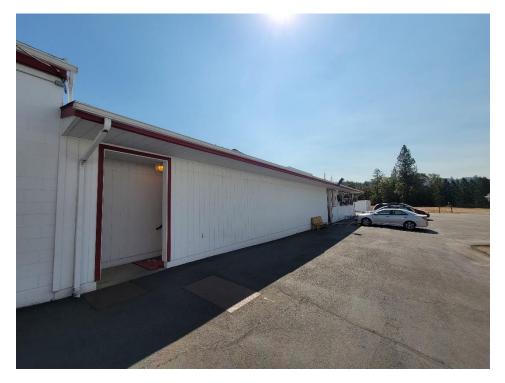
Figure 6: Western Wall of Gymnasium
