AHERA ASBESTOS SURVEY

DAYS CREEK CHARTER SCHOOL BUILDINGS

11381 Tiller-Trail Hwy., Days Creek, Oregon

DOUGLAS COUNTY SCHOOL DISTRICT 15 DAYS CREEK CHARTER SCHOOL

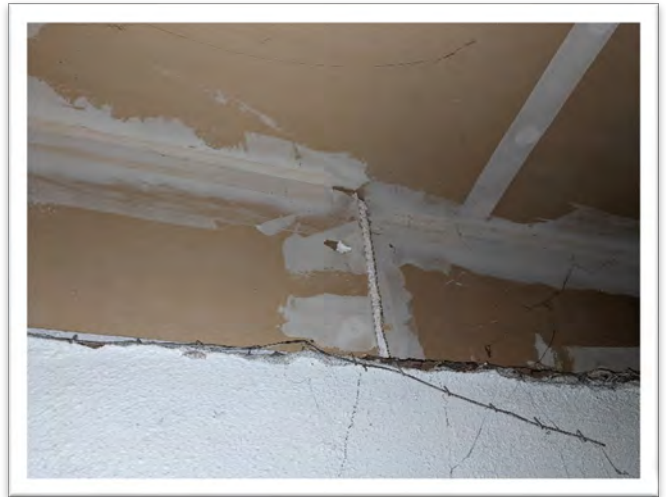
Sample 22-082A.91, Pipe Insulation, 80% Asbestos

Sample 22-082A.92, Pipe Insulation, 14% Asbestos

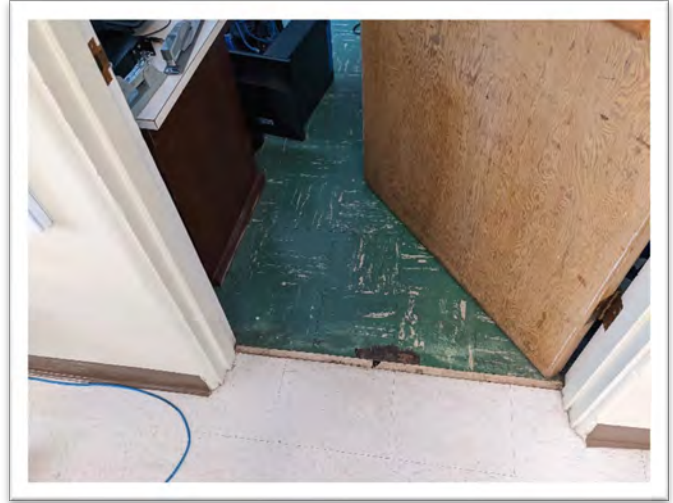
FLOOR TILE/BLACK MASTIC

BULK SAMPLE ANALYSIS RESULTS	
Sample # - Sample Location - % Asbestos / Type	
Sample # 22-082A.5,6	Boy's RR at Rm 203 – 3% Chrysotile
Sample # 22-082A.10	Room 203 Storage – 3% Chrysotile
Sample # 22-082A.12	Room 205 Closet – 3% Chrysotile
Sample # 22-082A.13	Knapp Closet – 3% Chrysotile
Sample # 22-082A.14	Dean Office – 3% Chrysotile
Sample # 22-082A.17	Server at Room 209 – 3% Chrysotile
Sample # 22-082A.18	Room 209 – 5% Chrysotile (Mastic)
Sample # 22-082A.19	Basement Closet – 5% Chrysotile
Sample # 22-082A.20	Paper Store – 2% Chrysotile (Mastic)
Sample # 22-082A.31	Gym Storage – 2% Chrysotile

MATERIAL DESCRIPTION	HOMOGENEOUS SAMPLING AREA	FUNCTIONAL SPACE	MATERIAL LOCATIONS	AHERA CATEGORY
Floor Tile Black Mastic	HSA-1 HSA-1A HSA-2	FS-1 FS-2 FS-3	Main School Building 1 st Floor and Basement	5

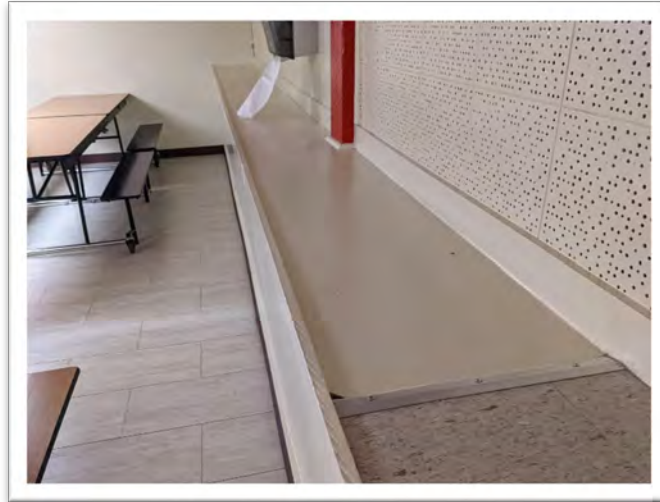
SHEET VINYL

BULK SAMPLE ANALYSIS RESULTS
Sample # - Sample Location - % Asbestos / Type
Sample # 22-082A.76 – Cafeteria Wall Shelf – 12% Chrysotile

MATERIAL DESCRIPTION	HOMOGENEOUS SAMPLING AREA	FUNCTIONAL SPACE	MATERIAL LOCATIONS	AHERA CATEGORY
Sheet Vinyl	HSA-1	FS-3	Cafeteria Back Wall Shelf	7

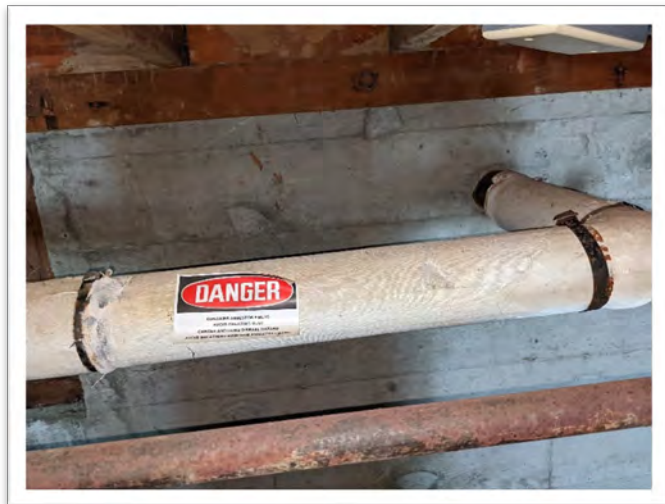
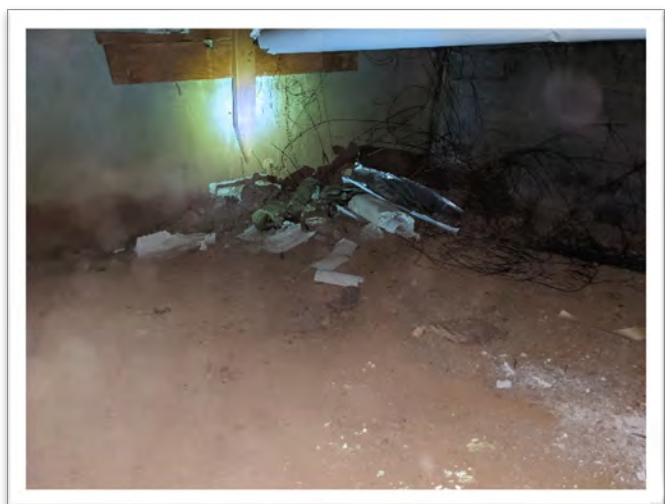
PIPE INSUALTION AND DEBRIS

BULK SAMPLE ANALYSIS RESULTS	
Sample # - Sample Location - % Asbestos / Type	
Sample # 22-082A.91	Main School Crawlspace – 80% Chrysotile
Sample # 22-082A.92	Main School Crawlspace – 12% Amosite, 2% Chrys.

MATERIAL DESCRIPTION	HOMOGENEOUS SAMPLING AREA	FUNCTIONAL SPACE	MATERIAL LOCATIONS	AHERA CATEGORY
Air Cell Pipe Insulation	HSA-1A	FS-1	Main School Building Crawlspace	1

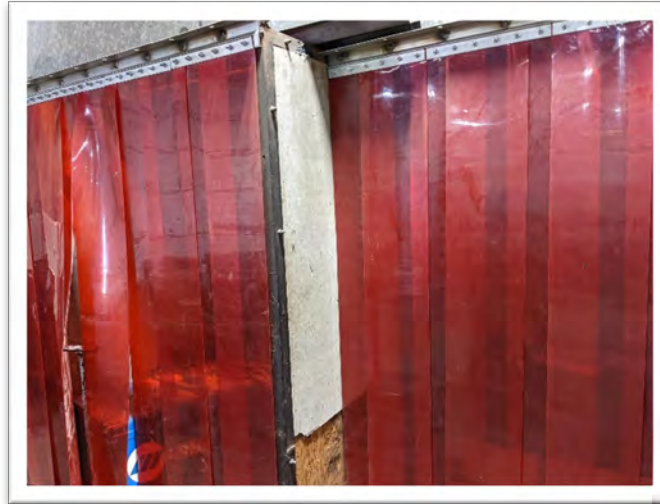
CEMENT BOARD

BULK SAMPLE ANALYSIS RESULTS
Sample # - Sample Location - % Asbestos / Type
Sample # 22-082A.119 – VoAg Building, Welding – 30% Chrysotile

MATERIAL DESCRIPTION	HOMOGENEOUS SAMPLING AREA	FUNCTIONAL SPACE	MATERIAL LOCATIONS	AHERA CATEGORY
Cement Board	HSA-5	FS-2	VoAg Building Welding Area	5

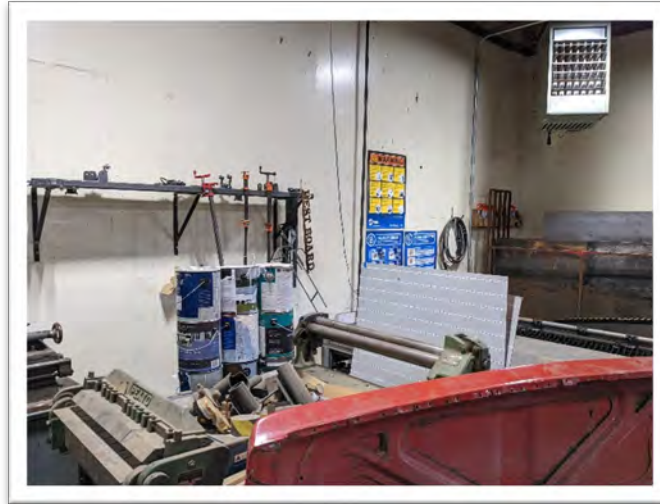
<1% ASBESTOS DRYWALL/MUD

BULK SAMPLE ANALYSIS RESULTS	
Sample # - Sample Location - % Asbestos / Type	
Sample # 22-082A.121	VoAg Building Wall, <1% Chrysotile
Sample # 22-082A.123	VoAg Building Restroom Wall, <1% Chrysotile
Sample # 22-082A.124	VoAg Building Restroom Wall, <1% Chrysotile
Sample # 22-082A.125	VoAg Building Classroom Wall, <1% Chrysotile
Sample # 22-082A.133	Super Residence Wall, 2% Chrysotile

MATERIAL DESCRIPTION	HOMOGENEOUS SAMPLING AREA	FUNCTIONAL SPACE	MATERIAL LOCATIONS	AHERA CATEGORY
Drywall/Mud	HSA-5 HAS-8	FS-2	VoAg Building Residence Building	X
